SUBJ: RCRA Compliance Evaluation Inspection  
Aerospace Coatings International, LLC  
EPA ID Number: ALR000026872

## **RCRA Inspection Report**

Aerospace Coatings International, LLC (ACI) in Oxford, Alabama, is an aircraft maintenance, repair and overhaul repair facility that specializes in hydraulic, pneumatic and landing gear piece part repair.

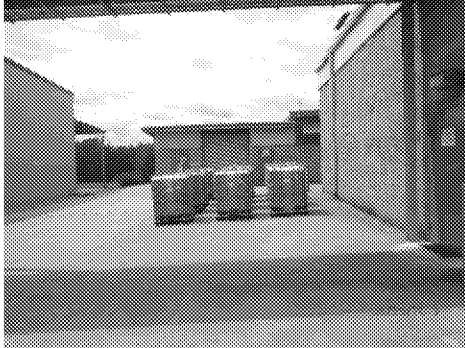
At the time of the inspection, thirteen 330-gallon hazardous waste totes of waste chromic acid were staged outside for pickup scheduled for that day (Pictures 1-3). The totes were closed, labeled (D002, D007) and all dated for June 25, 2019. Mr. Landingham explained that he was waiting on the transporter, and that the hazardous waste chromic acid was not considered waste prior to this day, but product for reuse until ready for disposal off-site. ACI stores used chromic acid, used nickel plating, used hydrochloric acid and other used products in totes in the staging area for further reuse until ready for disposal (Picture 14).

Picture [ SEQ Picture \\* ARABIC ] – Staging Area for Chromic Acid totes

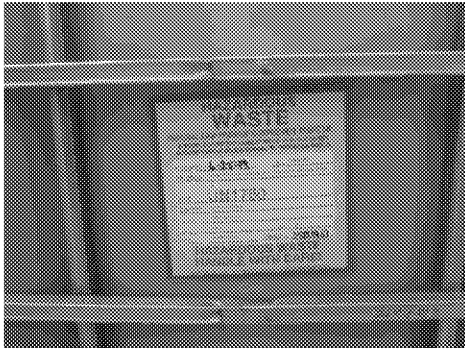
Picture [ SEQ Picture \\* ARABIC ] – Chromic Acid tote label

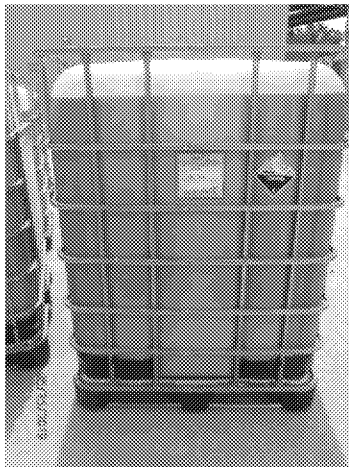
Picture [ SEQ Picture \\* ARABIC ] – Chromic Acid tote

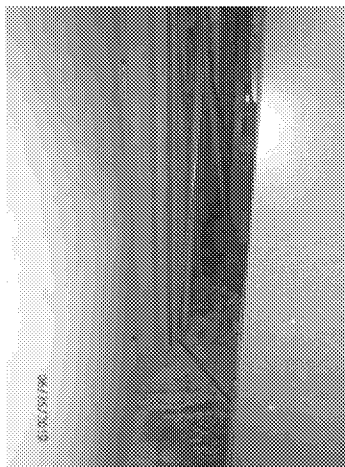
The inspectors also observed that the spent media was released to the floor. Mr. Landingham stated that housekeeping was ongoing and that the personnel assigned to the area would be back to sweep up the spent media.

Picture [ SEQ Picture \\* ARABIC ] – Staging Area spent blast media on the ground

**Pursuant to ADEM Admin. Code r. 335-14-3-.01(7)(a)6. [40 C.F.R. § 262.17(a)(6)], which incorporates ADEM Admin. Code r. 334-14-3-.14(2) [40 C.F.R. § 262.251], and is a condition of the LQG Permit Exemption, a generator is required to maintain and operate its facility to minimize the possibility of a fire, explosion, or any unplanned sudden or non-sudden release of hazardous waste or hazardous waste constituents to air, soil, or surface water which could threaten human health or the environment.**

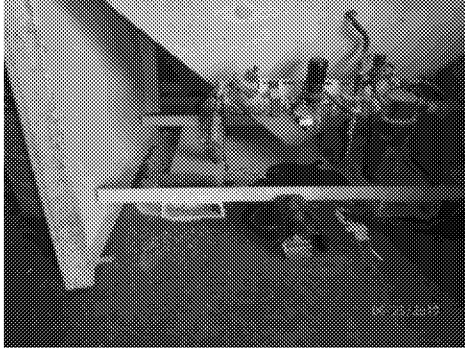
Picture [ SEQ Picture \\* ARABIC ] – Staging Area spent blast media on the ground

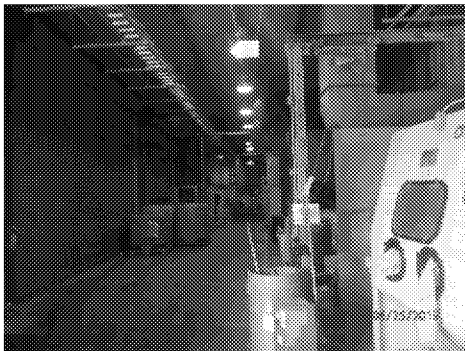
In addition, the inspectors observed a 330-gallon tote of Zyglo, two 330-gallon totes of nickel solution and one 220-gallon tote of hydrochloric acid being stored as product for reuse (Pictures 4-5). These containers were moved outside temporarily for the hazardous waste chromic acid totes to be staged. During the inspection, the four totes of product for reuse were moved back inside to the staging area.

Picture [ SEQ Picture \\* ARABIC ] – Staging Area for process materials for reuse

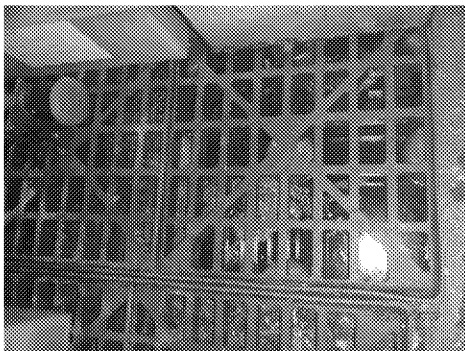
The Plating Room in the Outer Diameter (OD) Shop provides nickel, chromium, copper, cadmium, silver, magnesium phosphate and black oxide plating depending on client specifications. The different plating solutions are in small vats sitting on secondary containment. This plating room is used specifically for small aircraft parts. The inspectors observed a non-hazardous drum of nickel contaminated personal protective equipment (PPE) waste, a spill kit, the black oxide tank with visible corrosion on the surface, a 55-gallon SAA drum of chromic acid contaminated PPE that was not closed and the secondary containment pallet with overflow (Pictures 15-20). The inspectors recommended that the secondary containment be kept clean.

Picture [ SEQ Picture \\* ARABIC ] – Plating Room chromic acid secondary containment

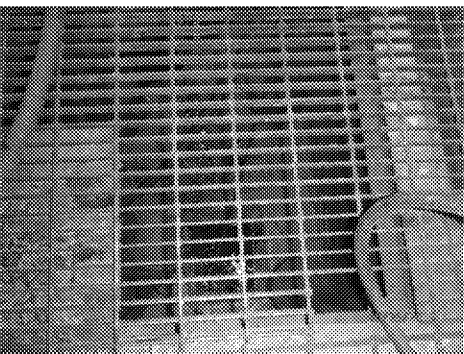
At the time of the inspection, the facility had released chromic acid into the secondary containment to conduct repairs to the process (Picture 25). The released chromic acid was being pumped into a 330-gallon tote for reuse (Picture 34).

Picture [ SEQ Picture \\* ARABIC ] – Chrome Plating  
release to sump

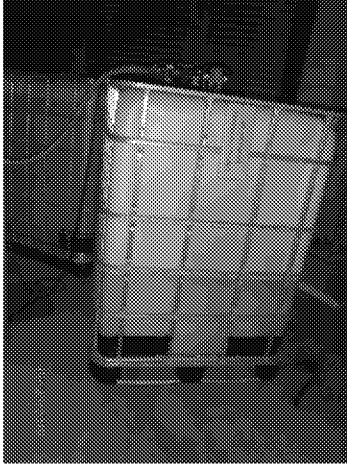
Picture [ SEQ Picture \\* ARABIC ] – Chrome Plating sump pump out tote

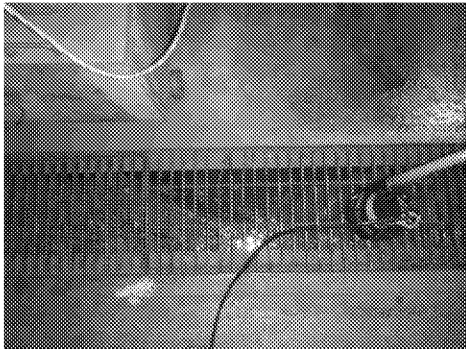
The OD Shop provides machining for the outer diameter of small aircraft parts. The inspectors observed a 55-gallon SAA drum of hazardous coolant sludge on a portable secondary containment (Pictures 35, 36, 39). The drum exterior and secondary containment was covered in coolant sludge. A second 55-gallon SAA drum of hazardous coolant sludge also had coolant sludge on the drum exterior (Pictures 43-45).

Picture [ SEQ Picture \\* ARABIC ] – OD Shop released hydraulic oil in floor grate

**Pursuant to ADEM Admin. Code r. 335-14-3-.01(7)(a)6. [40 C.F.R. § 262.17(a)(6)], which incorporates ADEM Admin. Code r. 334-14-3-.14(2) [40 C.F.R. § 262.251], and is a condition of the LQG Permit Exemption, a generator is required to maintain and operate its facility to minimize the possibility of a fire, explosion, or any unplanned sudden or non-sudden release of hazardous waste or hazardous waste constituents to air, soil, or surface water which could threaten human health or the environment.**

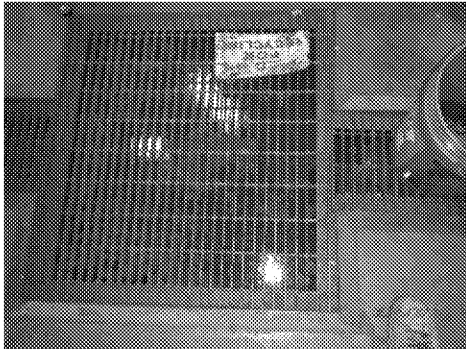
Picture [ SEQ Picture \\* ARABIC ] – OD Shop released hydraulic oil in floor grate

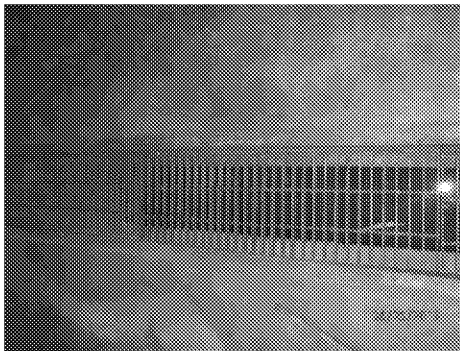
Another area of the OD Shop was the OD grinder for the landing strip gear. This area was not in operation at the time of the inspection. The inspectors observed releases of coolant under the machinery draining to the floor grate. The inspectors also noted that the floor grate was over half full of hydraulic oil, coolant and water (Pictures 46-49). The inspectors explained that leaving the material in the floor grate was storage and the material needed to be cleaned out of the floor grate.

Picture [ SEQ Picture \\* ARABIC ] – OD Shop Grinder for landing gear coolant release to floor grate

**Pursuant to ADEM Admin. Code r. 335-14-3-.01(7)(a)6. [40 C.F.R. § 262.17(a)(6)], which incorporates ADEM Admin. Code r. 334-14-3-.14(2) [40 C.F.R. § 262.251], and is a condition of the LQG Permit Exemption, a generator is required to maintain and operate its facility to minimize the possibility of a fire, explosion, or any unplanned sudden or non-sudden release of hazardous waste or hazardous waste constituents to air, soil, or surface water which could threaten human health or the environment.**

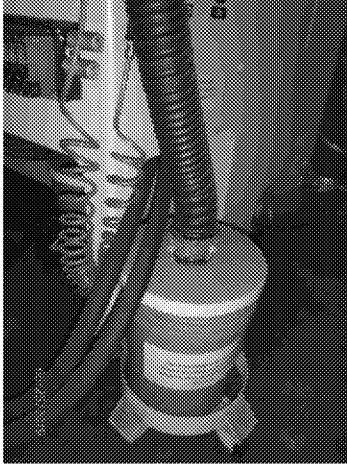
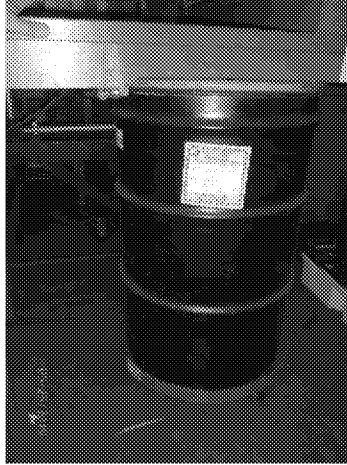
The Shot Peen media blaster was in the OD Shop. This media blaster was self-contained, and no spent media was observed on the floor. However, the 5-gallon SAA container used to capture the spent blast media was not labeled, but the 55-gallon SAA drum of spent blast media from the Shot Peen media blaster was labeled as hazardous waste (Pictures 50-53).

Picture [ SEQ Picture \\* ARABIC ] – OD Shop Shot Peen spent blast media

**Pursuant to ADEM Admin. Code r. 335-14-3-.01(5)(a)4 [40 C.F.R. § 262.15(a)(4)], which is a condition of the SAA Permit Exemption, a generator is required to keep containers of hazardous waste closed at all times during accumulation, except when adding, removing, or consolidating waste; or when temporary venting of a container is necessary for the proper operation of equipment, or to prevent dangerous situations, such as build-up of extreme pressure.**

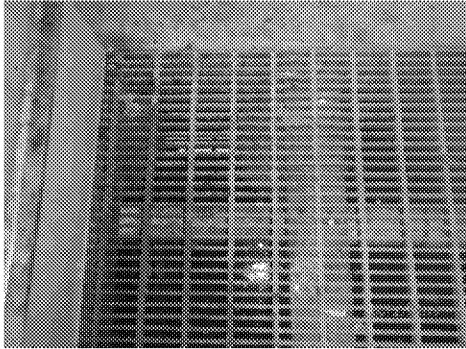
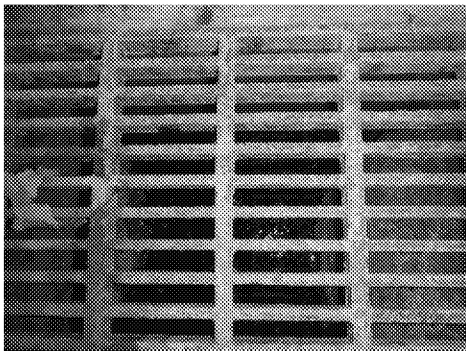
The Stripper Shop is a separate building that contains vats of sodium hydroxide and hydrochloric acid rinses. The inspectors observed the secondary containment underneath the floor grate was over half full with overflow of spent acid rinse (Pictures 54-56). The inspectors stated that the secondary containment needed to be pumped out.

Picture [ SEQ Picture \\* ARABIC ] – Stripper Shop floor grate filled with acidic rinse water

**Pursuant to ADEM Admin. Code r. 335-14-3-.01(7)(a)6. [40 C.F.R. § 262.17(a)(6)], which incorporates ADEM Admin. Code r. 334-14-3-.14(2) [40 C.F.R. § 262.251], and is a condition of the LQG Permit Exemption, a generator is required to maintain and operate its facility to minimize the possibility of a fire, explosion, or any unplanned sudden or non-sudden release of hazardous waste or hazardous waste constituents to air, soil, or surface water which could threaten human health or the environment.**

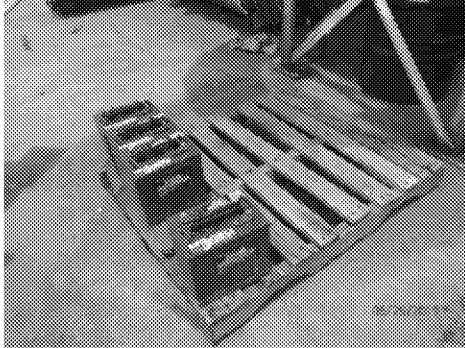
The inspectors also observed four lead acid batteries on a pallet near one of the dust collectors (Picture 59). Maintenance personnel explained that the batteries were new and had been moved out of the old maintenance shop during clean up. The personnel used a forklift to take the batteries into the new maintenance shop.

Picture [ SEQ Picture \\* ARABIC ] – Maintenance new lead acid batteries

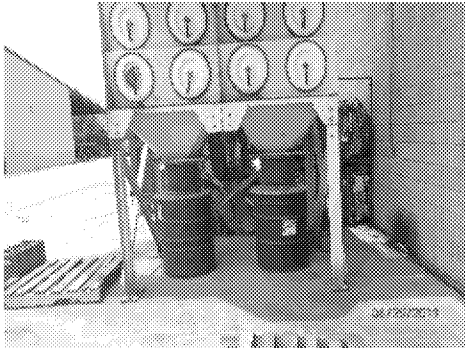
generator knowledge to be non-hazardous waste (Picture 57). Near the Plasma Dust Collector were two general dust collection hoppers and drums (Pictures 58, 60). These 55-gallon drums were also considered to be non-hazardous waste via generator knowledge. The inspectors stated that due to the nature of the facility operations waste analyses should be done on the dust collected prior to the next disposal.

Picture [ SEQ Picture \\* ARABIC ] – General Dust collector drums

**Pursuant to ADEM Admin. Code r. 335-14-3-.01(2) [40 C.F.R. § 262.11], a person who generates a solid waste, as defined in ADEM Admin. Code r. 335-14-2-.01(2) [40 C.F.R. § 261.2], must make an accurate determination as to whether that waste is a hazardous waste in order to ensure wastes are properly managed according to applicable RCRA regulations.**

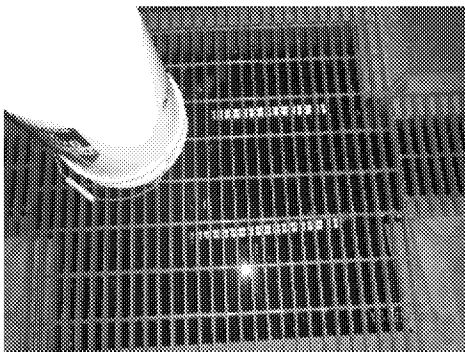
The inspectors toured the ID Shop and observed one 55-gallon SAA drum of chromic debris, an Alodine dip stations and the floor grating half full of hydraulic oil, coolant and water. The inspectors explained that leaving the hydraulic oil, coolant and water in the floor grating was storage and the material needed to be cleaned out of the floor grating.

Picture [ SEQ Picture \\* ARABIC ] – ID Shop floor grate sump

**Pursuant to ADEM Admin. Code r. 335-14-3-.01(7)(a)6. [40 C.F.R. § 262.17(a)(6)], which incorporates ADEM Admin. Code r. 334-14-3-.14(2) [40 C.F.R. § 262.251], and is a condition of the LQG Permit Exemption, a generator is required to maintain and operate its facility to minimize the possibility of a fire, explosion, or any unplanned sudden or non-sudden release of hazardous waste or hazardous waste constituents to air, soil, or surface water which could threaten human health or the environment.**

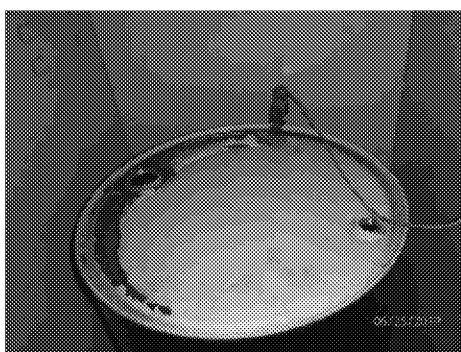
Picture [ SEQ Picture \\* ARABIC ] – Maintenance HW  
MEK SAA open

**Pursuant to ADEM Admin. Code r. 335-14-3-.01(5)(a)4 [40 C.F.R. § 262.15(a)(4)], which is a condition of the SAA Permit Exemption, a generator is required to keep containers of hazardous waste closed at all times during accumulation, except when adding, removing, or consolidating waste; or when temporary venting of a container is necessary for the proper operation of equipment, or to prevent dangerous situations, such as build-up of extreme pressure.**

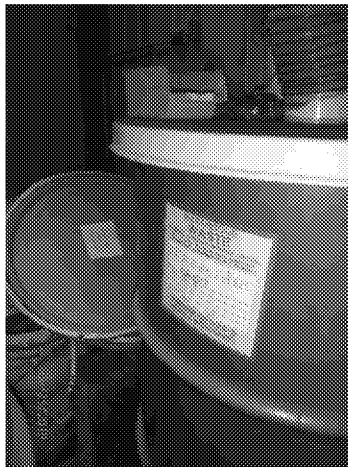
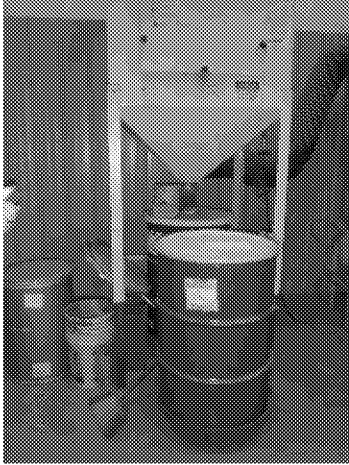
The Landing Gear Shop was a separate building that specialized in landing gear repair. The inspectors toured the shop and observed an aluminum oxide media blaster with two 55-gallon SAA drums of spent blast media (Pictures 77-80). One drum was attached the media blaster hopper and the second drum was sitting in front of the hopper and not closed.

Picture [ SEQ Picture \\* ARABIC ] – Landing Gear Shop  
spent blast media

Pursuant to ADEM Admin. Code r. 335-14-3-.01(5)(a)4 [40 C.F.R. § 262.15(a)(4)], which is a condition of the SAA Permit Exemption, a generator is required to keep containers of hazardous waste closed at all times during accumulation, except when adding, removing, or consolidating waste; or when temporary venting of a container is necessary for the proper operation of equipment, or to prevent dangerous situations, such as build-up of extreme pressure.

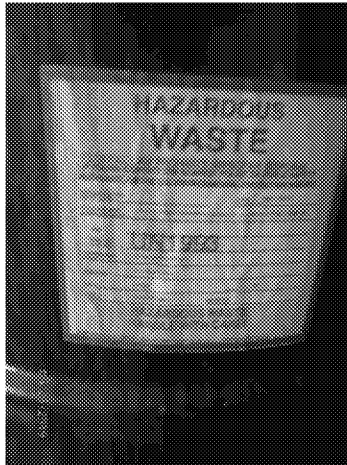
Picture [ SEQ Picture \\* ARABIC ] – CAA HW MEK waste label no date
